A STUDY OF THE EFFECT OF SURFACE FILMS  
ON FATIGUE FRACTURE

ANNUAL SUMMARY REPORT  
15 August 1963 - 14 August 1964

MRI Project No. RA-14-P

MIDWEST RESEARCH INSTITUTE

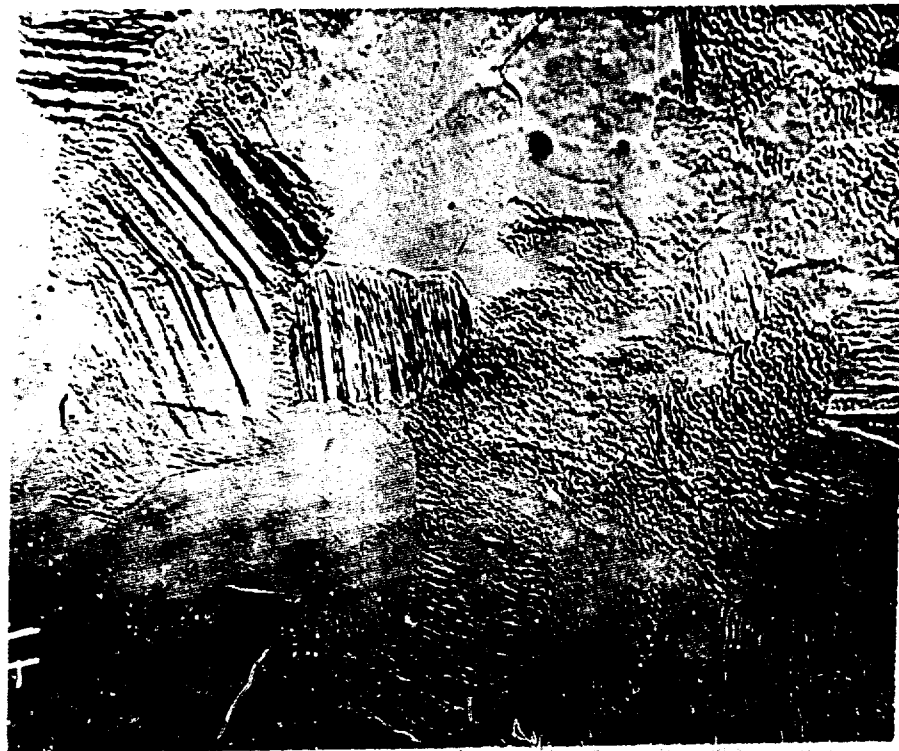
$4 \times 10^{-9}$  TORR

760 TORR

FIG. 2 - Optical Micrographs of Low-Strain Polycrystalline Aluminum  
Deformed 5,000 Cycles at  $\pm 5.2 \times 10^{-4}$  Strain

Surface slip patterns: Optical micrographs of surfaces of the four samples are given in Figs. 2 and 3. A statistical analysis made of the slip patterns in the various grains showed that at the high strain amplitude the surface slip distribution was essentially the same at 760 Torr and at  $4 \times 10^{-9}$  Torr. At low-strain amplitude, however, significantly fewer slip bands were found on the surface of the sample strained in high vacuum. Electron micrographs of surface replicas were taken of the low-strain samples and typical results are shown in Fig. 4. The distinguishing feature is that practically every grain of the sample cycled in UHV was covered with fine slip while the samples cycled in air tended to have slip concentrated into bands with no observable slip between the bands. In all cases of fine slip, the spacing was of the order of  $700 \text{ \AA}$ . The average slip height in the vacuum runs was 50 -  $100 \text{ \AA}$  while at atmospheric pressure the slip height ranged from 90 -  $300 \text{ \AA}$ .

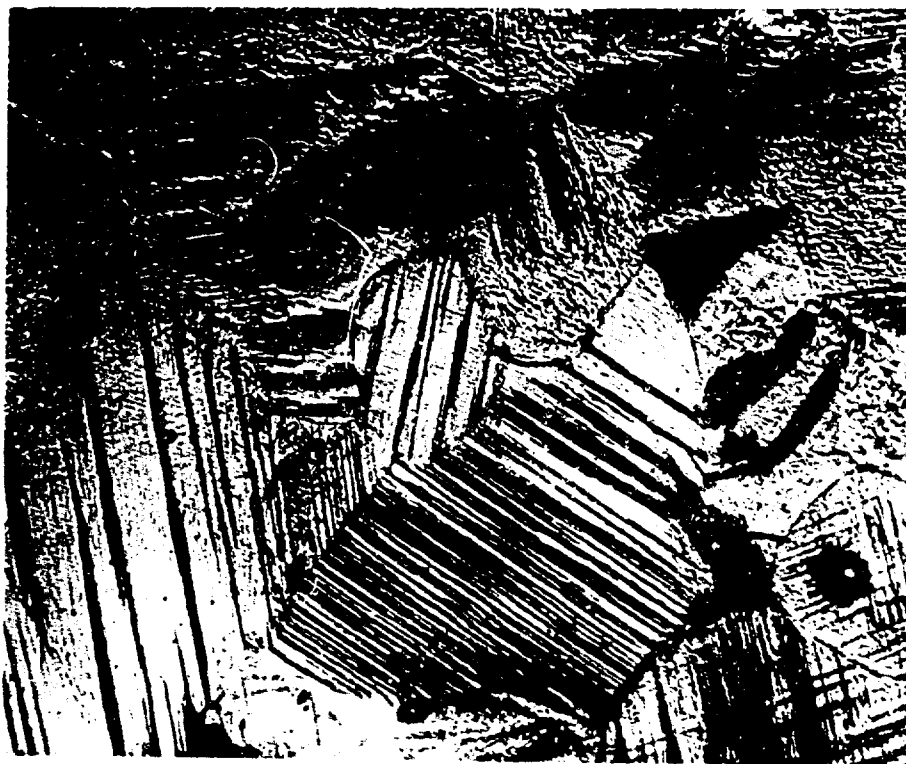
4 x 10<sup>-9</sup> TORR

760 TORR

FIG. 3 - Optical Micrographs of Low-Strain Polycrystalline Aluminum  
Deformed 5,000 Cycles at  $\pm 1.3 \times 10^{-3}$  Strain

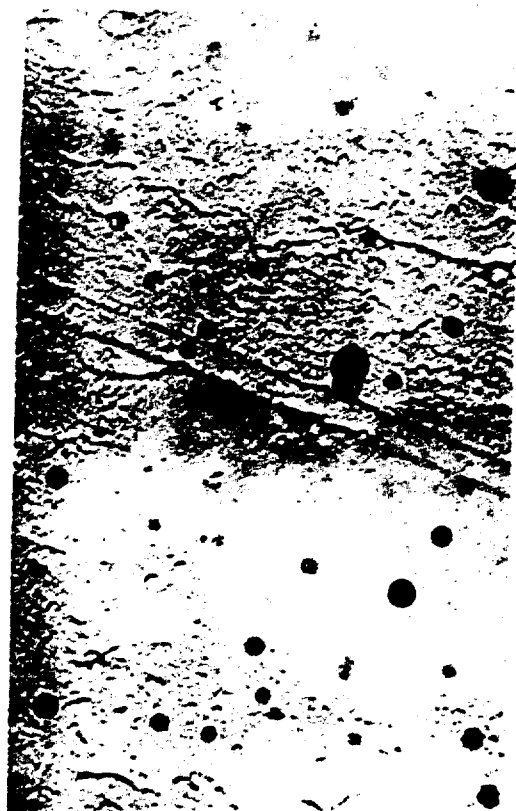
(a) Natural Oxide Surface

(b) 100 Å Oxide Surface

(c) 300 Å Oxide Surface

(d) 1,000 Å Oxide Surface

Fig. 10 - Electron Micrographs of Formvar Surface Replicas of the Aluminum Single Crystal  
Deformed at 760 Torr for 5,000 Cycles at  $6 \times 10^{-4}$  Strain

The results can be stated briefly for the sample cycled at atmospheric pressure. The top surface of the anodic layers showed evidence of slip in all cases except the 1,000 Å layer. Examples are shown in Fig. 10. The fine slip within the broad slip bands observed on the natural oxide layer (Fig. 10(a)) was not observed on the two heavier anodic layers. The anodic layer surface at the oxide-metal interface showed no evidence of slip for either the 300 Å or 1,000 Å layer. It was not possible to replicate this surface in the case of the 100 Å or natural oxide layer. Direct replicas of the metal surface showed slip under both the 100 Å layer and the 300 Å layer. Some questionable examples of slip were found under the 1,000 Å layer. Representative micrographs are shown in Fig. 11. The resolution in these latter pictures leaves much to be desired, mainly because of the attack of the solution used to remove the anodic layers.
